Manhole Inspection Summary

Manhole # S23K__027MH

Location Address: **S Stricker**

Cross Street: **Ramsey St**

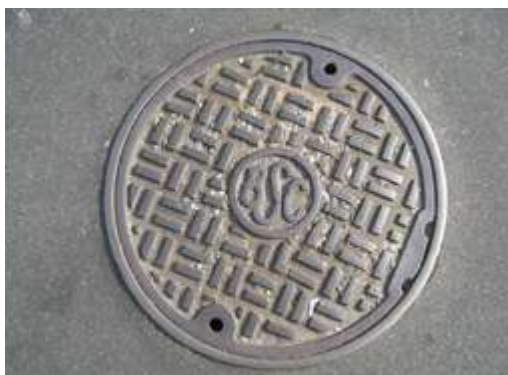
Cover View

Type: **Sanitary** Condition: **Worn** Cover Material: **Cast Iron**

Frame Offset: **0** (in.) Condition: ☐ Sound ☐ Cracked ☒ **Leaks**
